**Flood Control Project Maintenance
Levee Inspections**
LMA District Cover Sheet
Spring 2019 Levee Inspection Results

Levee District No. 0002 (Glenn County)

Waterway			Bank	Unit Miles
Unit No. 01 Glenn County Sacramento River			Right	4.90
	Spring (March - May)	Summer (June - August)	(September - November) Fall	Winter (December - February)
Unit Maintenance Rating (Fall Only)				
Date of Inspection	4/4/2019 - 4/4/2019			
DWR Inspector	Makar Sokol			
Accompanied By	Dennis Clark LD 2			
	Mike Engelmann

Levee Inspection Report By Mile - Spring 2019

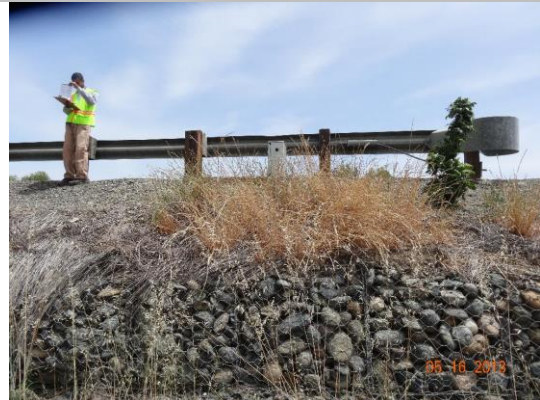
Photo 1 of 3 : UCIP_SP_2019_42083_72882.jpg

LM Start	0.59	Rating **	M	Issue No.	58	
LM End	0.59	Issue Type +	En	Location *		
Category	Supplemental			GPS Latitude/Longitude		
				Start	End	
Item	DWR UCIP Field Study			39.422088 °	39.422088 °	
				-122.011615 °	-122.011615 °	
DWR ID	24877					
Comment Code						
Inspector Comment						
FS_ID:42083 DS_ID:24877 EP_NO: N/A Repair Type: Non-Urgent Crossing Status: Indicator Found UCIP Comments: Need to contact owner to determine if conduit goes through levee crown. If it does, will need to obtain permit number issued for encroachment. FIELD_STRUCT_DESC: Caltrans traffic control box located on the landside (LS) shoulder. FS Date: 5/16/2013

View of landward slope.

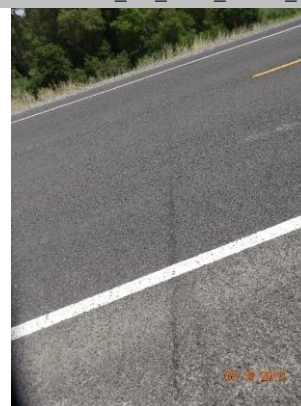
Photo 2 of 3 : UCIP_SP_2019_42083_72881.jpg

LM Start	0.59	Rating **	M	Issue No.	58 (cont)	
LM End	0.59	Issue Type +	En	Location *		
Category	Supplemental			GPS Latitude/Longitude		
				Start	End	
Item	DWR UCIP Field Study			39.422088 °	39.422088 °	
				-122.011615 °	-122.011615 °	
DWR ID	24877					
Comment Code						
Inspector Comment						
FS_ID:42083						
DS_ID:24877						
EP_NO: N/A						
Repair Type: Non-Urgent						
Crossing Status: Indicator Found						
UCIP Comments: Need to contact owner to determine if conduit goes through levee crown. If it does, will need to obtain permit number issued for encroachment.						
FIELD_STRUCT_DESC: Caltrans traffic control box located on the landside (LS) shoulder.						
FS Date: 5/16/2013

View of levee crown at crossing.

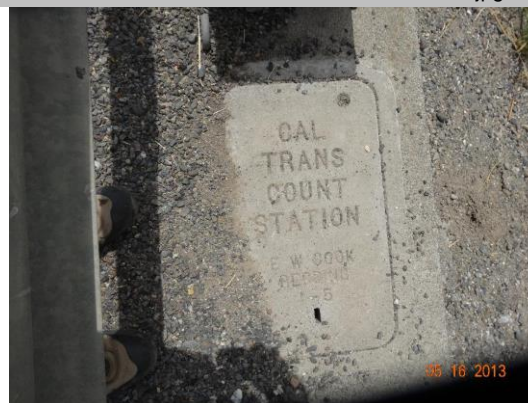
Photo 3 of 3 : UCIP_SP_2019_42083_72880.jpg

Service box located on landward shoulder.

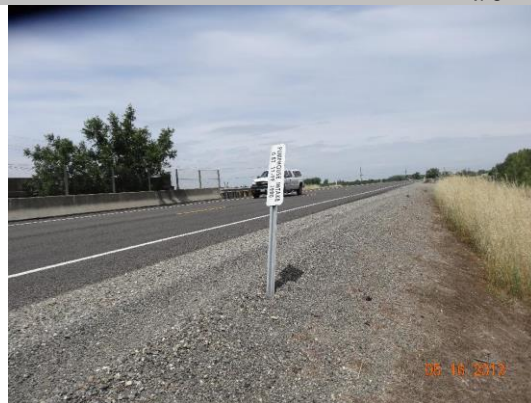
Photo 1 of 3 : UCIP_SP_2019_38165_69467.jpg

Comment Code					
Inspector Comment					
FS_ID:38165 DS_ID:21185 EP_NO: 2356 Repair Type: Non-Urgent Crossing Status: Found UCIP Comments: Three pipes found in the pump house on landward side. Pump house appears to be no longer in use. Unable to locate pipes on waterward side. Will need to contact owner to determine status. Owner will need to coordinate with CVFPB regarding proper removal per Title 23 requirements. FIELD_STRUCT_DESC: [Princeton-Cordora-Glenn Irrigation District: Schaad Pumping Plant] 1 of 3: 28-inch steel pipe sleeved through 30-inch steel pipe through the levee, 20 feet below the crown. Annular gap is grouted. Flap gate on landside (LS) end. Pump in pump house on LS slope. Rock revetment around outlet on waterside (WS) slope. (28- and 34-inch pipes sleeved through existing 30- and 36-inch pipes, permit shows three 36-inch pipes as part of Schaad Pumping Plant p. 17 of 19, authorized under Permit No. 2356, 1956, Princeton-Cordora-Glenn Irrigation District) [Additional Reference(s): DWR Levee Logs, 2005. USACE Sacramento O&M Manual Unit No. 151, November 1953, (Station 41+47), two 36-inch pipes] FS Date: 5/16/2013

View of levee crown at crossing.

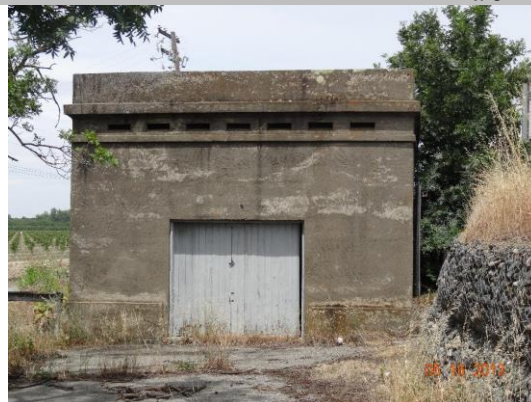
Photo 2 of 3 : UCIP_SP_2019_38165_69469.jpg

View of Princeton-Cordora-Glenn Irrigation District--Schaad Pumping Plant.

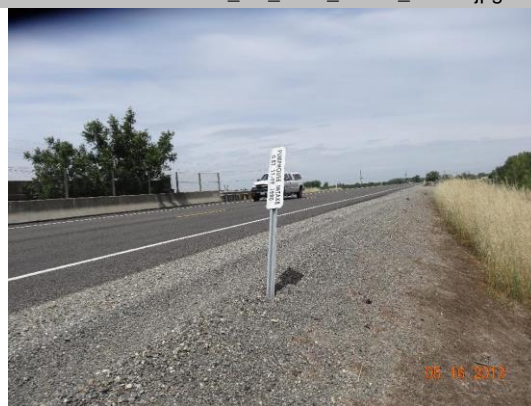
Photo 1 of 3 : UCIP_SP_2019_38166_69475.jpg

Comment Code					
Inspector Comment					
FS_ID:38166 DS_ID:21184 EP_NO: N/A Repair Type: Non-Urgent Crossing Status: Found UCIP Comments: Three pipes found in the pump house on landward side. Pump house appears to be no longer in use. Unable to locate pipes on waterward side. Will need to contact owner to determine status. Owner will need to coordinate with CVFPB regarding proper removal per Title 23 requirements. FIELD_STRUCT_DESC: [Princeton-Cordora-Glenn Irrigation District: Schaad Pumping Plant] 2 of 3: 34-inch steel pipe sleeved through 36-inch steel pipe through the levee, 20 feet below the crown. Annular gap is grouted. Flap gate on landside (LS) end. Pump in pump house on LS slope. Rock revetment around outlet on waterside (WS) slope. (28- and 34-inch pipes sleeved through existing 30- and 36-inch pipes, permit shows three 36-inch pipes as part of Schaad Pumping Plant p. 17 of 19, authorized under Permit No. 2356, 1956, Princeton-Cordora-Glenn Irrigation District) [Additional Reference(s): DWR Levee Logs, 2005. USACE Sacramento O&M Manual Unit No. 151, November 1953, (Station 41+47), two 36-inch pipes] FS Date: 5/16/2013

View of levee crown at crossing.

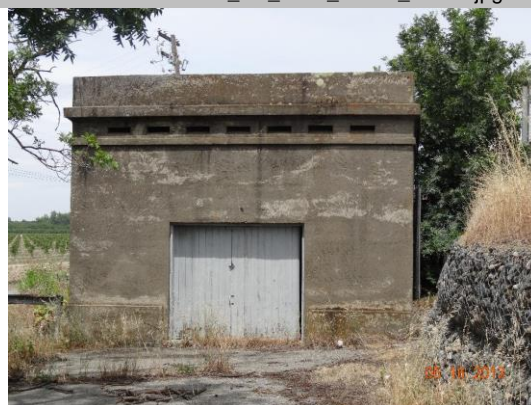
Photo 2 of 3 : UCIP_SP_2019_38166_69476.jpg

View of Princeton-Cordora-Glenn Irrigation District--Schaad Pumping Plant.

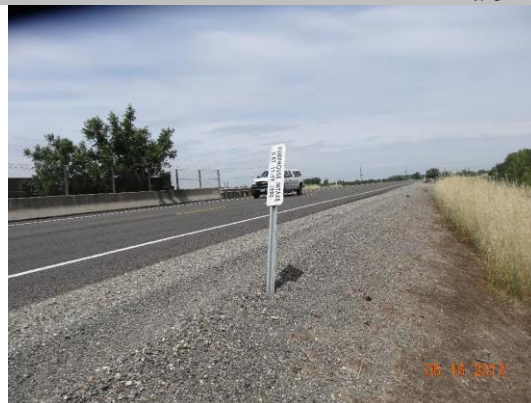
Photo 1 of 3 : UCIP_SP_2019_38167_69483.jpg

UCIP Comments: Three pipes found in the pump house on landward side. Pump house appears to be no longer in use. Unable to locate pipes on waterward side. Will need to contact owner to determine status. Owner will need to coordinate with CVFPB regarding proper removal per Title 23 requirements.

View of levee crown with marker on waterward side.

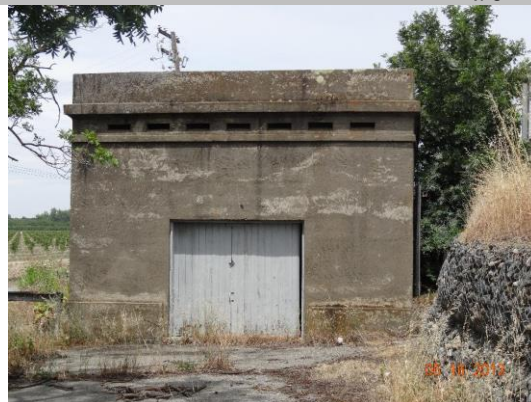
Photo 2 of 3 : UCIP_SP_2019_38167_69484.jpg

View of Princeton-Cordora-Glenn Irrigation District-Schaad Pumping Plant.

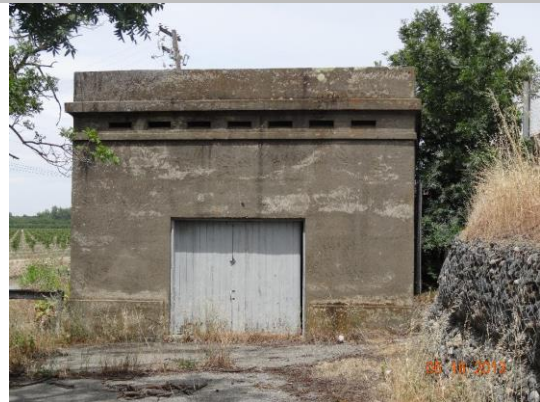
Photo 2 of 3 : UCIP_SP_2019_38168_69493.jpg

View of Princeton-Cordora-Glenn Irrigation District-Schaad Pumping Plant.

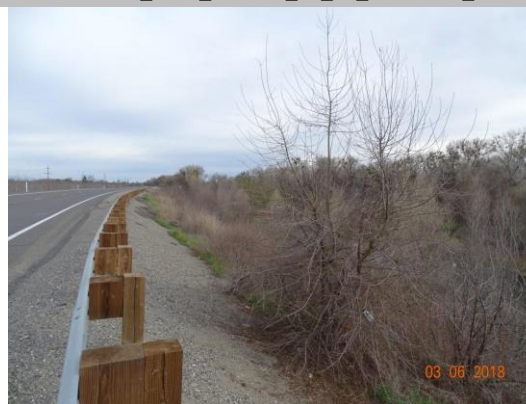
Photo 1 of 1 : SP_2019_LD0002_28_35_20190320_00017.jpg

LM Start	0.64	Rating **	M	Issue No.	35
LM End	0.77	Issue Type +	Ma	Location *	WS
Category	Earthen Levee			GPS Latitude/Longitude	
				Start	End
Item	Vegetation			39.422805 °	39.424597 °
				-122.011640 °	-122.011527 °
DWR ID	DWR_LD0002_01_s_2018_35				
Comment Code					
V2 : Remove the wild growth other than native grasses from the levee slopes.					
Inspector Comment

View of the vegetation along the waterside slope.

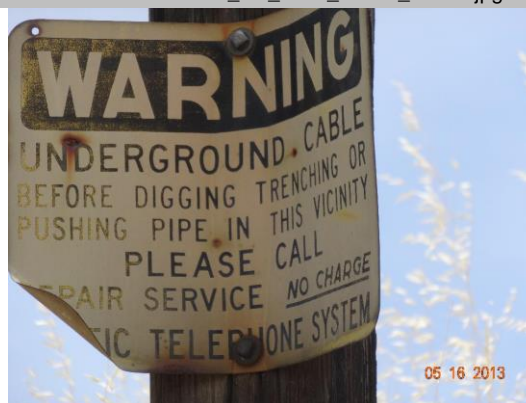
Photo 3 of 3 : UCIP_SP_2019_44170_72600.jpg

Comment Code						
Inspector Comment						
FS_ID:44170 DS_ID:21177 EP_NO: 9723 Repair Type: Non-Urgent Crossing Status: Indicator Found UCIP Comments: Owner is listed as Pacific Bell however sign lists AT&T as owner, need to contact owner to determine if permit was updated or if this crossing is listed under new permit. Unable to confirm if 2 crossings are present at this site. FIELD_STRUCT_DESC: Buried telephone cable through the levee at unknown depth. Telephone pole and junction box on landside (LS) toe. (telephone cable authorized under Automatic Board Order (ABO) issued as Permit No. 9723-1974, Pacific Telephone Company). FS Date: 5/16/2013

Sign lists Pacific Telephone system.

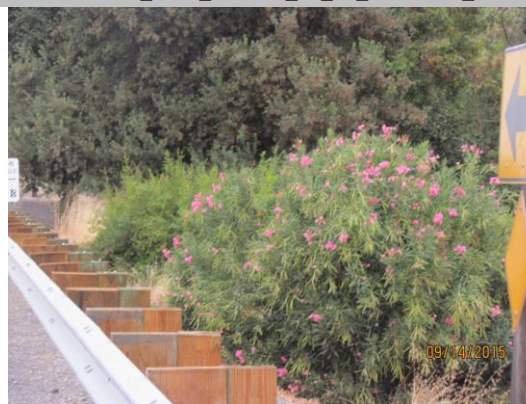
Photo 1 of 1 : SP_2019_LD0002_28_30_20190320_00014.jpg

LM Start	1.03	Rating **	M	Issue No.	30
LM End	1.03	Issue Type +	En	Location *	WS
Category	Earthen Levee			GPS Latitude/Longitude	
				Start	End
Item	Vegetation			39.428445 °	39.428445 °
				-122.010972 °	-122.010972 °
DWR ID	DWR_LD0002_01_f_2015_30				
Comment Code					
V6 : Landscaping					
Inspector Comment					
Remove the oleanders from the waterside slope.

View of the oleanders along the waterside slope.

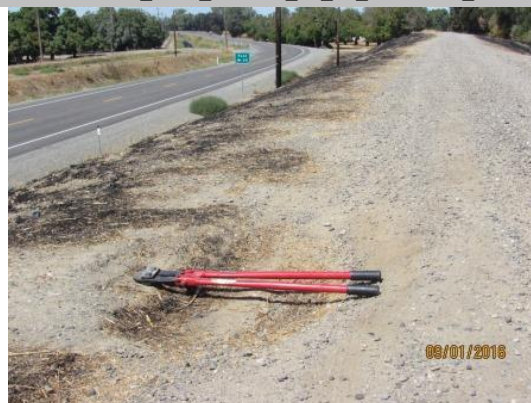
Photo 1 of 1 : SP_2019_LD0002_28_34_20190320_00016.jpg

LM Start	1.40	Rating **	M	Issue No.	34
LM End	1.40	Issue Type +	Ma	Location *	CR
Category	Earthen Levee			GPS Latitude/Longitude	
				Start	End
Item	Crown Surface / Depressions / Rutting			39.433809 °	39.433809 °
				-122.010814 °	-122.010814 °
DWR ID	DWR_LD0002_01_f_2016_34				
Comment Code					
C2 : Repair depressions or ruts in the crown or slope.					
Inspector Comment

View of a depression on the levee crown looking upstream.

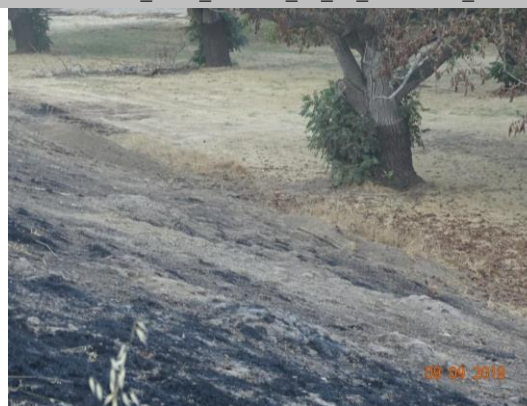
Photo 1 of 1 : SP_2019_LD0002_28_15_20190320_00007.jpg

View of the rodent holes along the landside slope.

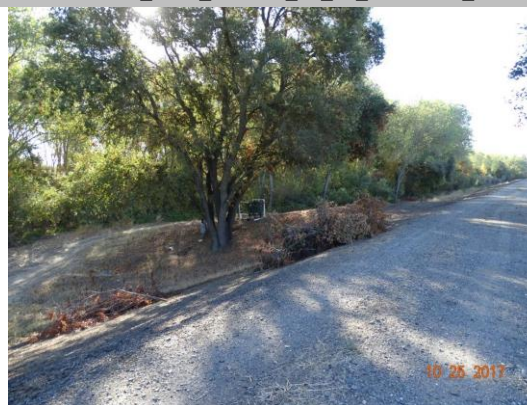
Photo 1 of 1 : SP_2019_LD0002_28_32_20190320_00015.jpg

LM Start	1.62	Rating **	M	Issue No.	33
LM End	1.62	Issue Type +	En	Location *	LS
Category	Earthen Levee			GPS Latitude/Longitude	
				Start	End
Item	Encroachments			39.436903 °	39.436903 °
				-122.010475 °	-122.010475 °
DWR ID	DWR_LD0002_01_s_2019_33				
Comment Code					
DE : Debris					
Inspector Comment

View of the prunings along the waterside slope.

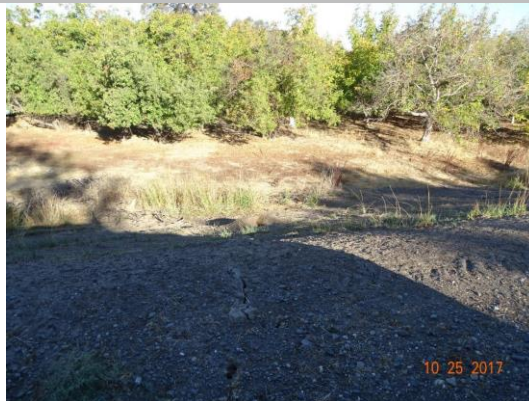
Photo 1 of 2 : SP_2019_LD0002_28_2_20190320_00001.jpg

View of the rodent holes along the landside slope.

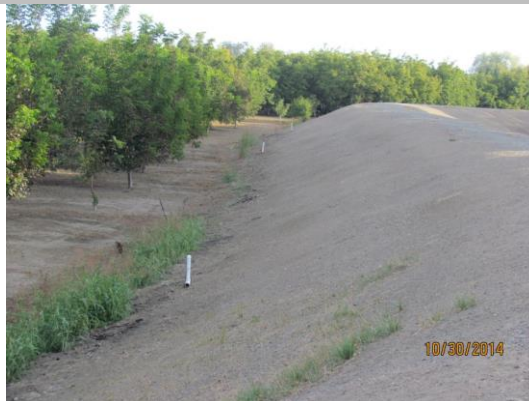
Photo 2 of 2 : SP_2019_LD0002_28_2_20190320_00002.jpg

LM Start	2.91	Rating **	U	Issue No.	2 (cont)
LM End	2.96	Issue Type +	Ma	Location *	LS

View of the rodent holes and bait station along the landside slope.

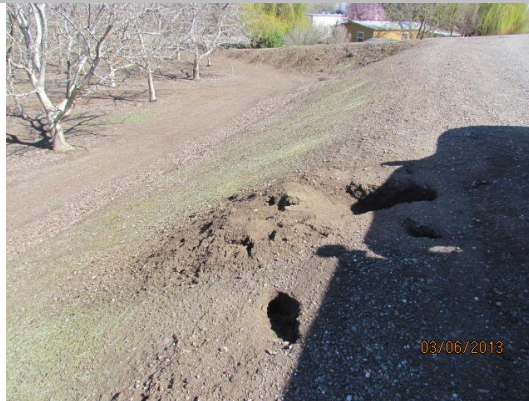
Photo 1 of 1 : SP_2019_LD0002_28_12_20190320_00005.jpg

LM Start	3.11	Rating **	U	Issue No.	12
LM End	3.16	Issue Type +	Ma	Location *	LS
Category	Earthen Levee			GPS Latitude/Longitude	
				Start	End
Item	Animal Control			39.455647 °	39.456004 °
				-122.013623 °	-122.012776 °
DWR ID	DWR_LD0002_01_s_2013_12				
Comment Code					
A1 : Exterminate rodents and backfill and compact or grout burrows.					
Inspector Comment

View of the rodent activity along the landside slope.

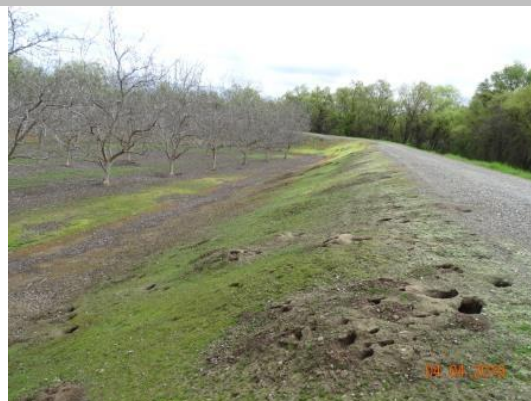
Photo 3 of 4 : SP_2019_LD0002_28_16_20190411_00053.jpg

LM Start	3.23	Rating **	U	Issue No.	16 (cont)
LM End	3.30	Issue Type +	Ma	Location *	LS

View of the rodent holes along the landside slope. Spring 2019.

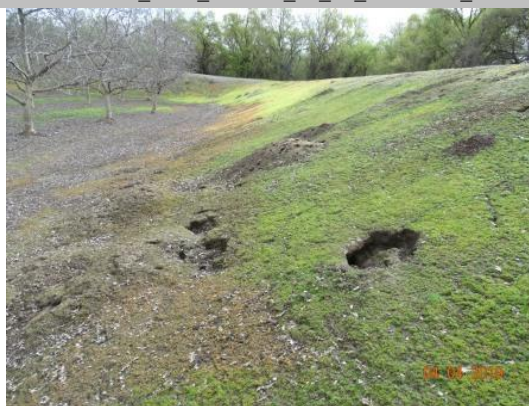
Photo 4 of 4 : SP_2019_LD0002_28_16_20190411_00054.jpg

Another view of the rodent holes along the landside slope. Spring 2019.

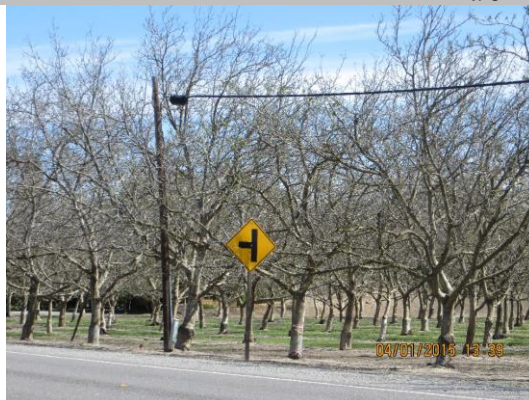
Photo 1 of 2 : UCIP_SP_2019_44186_73606.jpg

Comment Code						
Inspector Comment						
FS_ID:44186						
DS_ID:21188						
EP_NO: 12444						
Repair Type: Non-Urgent						
Crossing Status: Indicator Found						
UCIP Comments: Needs markers 10-feet off both levee toes.						
FIELD_STRUCT_DESC: Buried cable steel conduit through the levee,

Conduit may be visible on pole about 1000-feet west of levee crown.

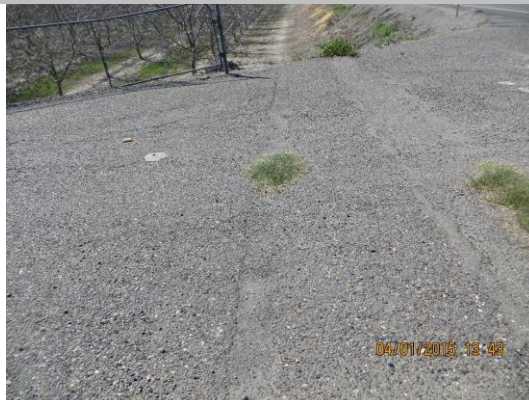
Photo 2 of 2 : UCIP_SP_2019_44186_73605.jpg

Cut in pavement at levee crown good indicator of crossing.

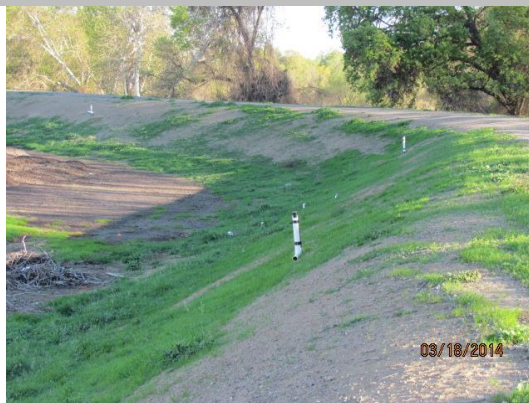
Photo 1 of 2 : SP_2019_LD0002_28_27_20190320_00011.jpg

View of the rodent activity along the landside slope.

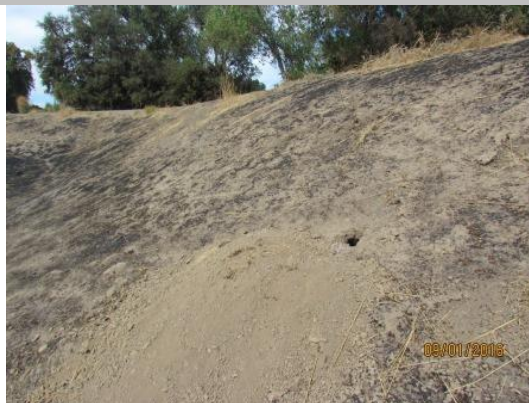
Photo 2 of 2 : SP_2019_LD0002_28_27_20190320_00012.jpg

LM Start	3.44	Rating **	U	Issue No.	27 (cont)
LM End	3.52	Issue Type +	Ma	Location *	LS

View of the rodent holes along the landside slope.

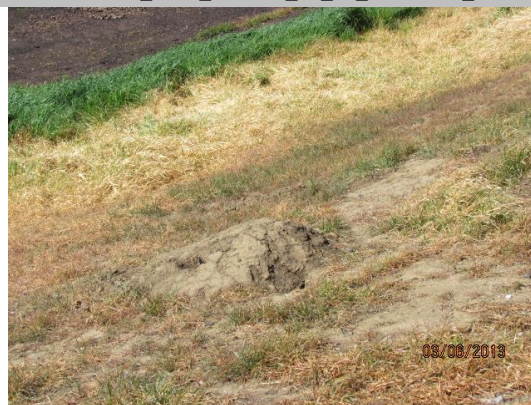
Photo 1 of 1 : SP_2019_LD0002_28_13_20190320_00006.jpg

View of the rodent activity along the landside slope.

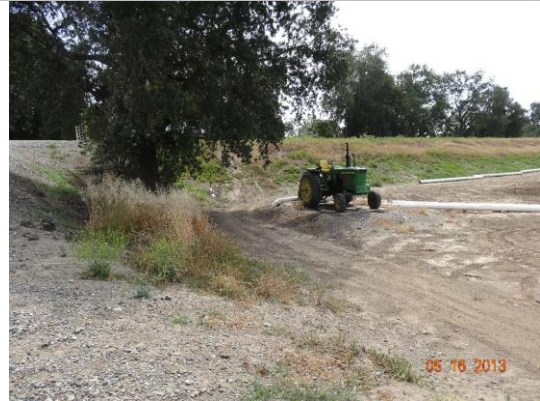
Photo 1 of 3 : UCIP_SP_2019_38178_69502.jpg

Comment Code						
Inspector Comment						
FS_ID:38178 DS_ID:21178 EP_NO: 16931 Repair Type: Non-Urgent Crossing Status: Indicator Found UCIP Comments: Inspector notes indicate that pipe was never installed through levee and application was closed. Steel pipe was not installed but detachable section was installed. The pipe section goes up and over levee. Permit 16931 file was closed in 2005 owner was unable to install pipe due to costs. Permit indicates that pipe was to be used for winter supply of irrigation water to landward side. Need to coordinate with DWR inspector--permit revised for this type of structure. FIELD_STRUCT_DESC: Crossing visible at location. Current structure differs from original request in Permit No. 16931. PVC connection visible on landside (LS) toe with cutoff valve. Pipe connects to 8-inch PVC pipe extending past LS toe. FS Date: 5/16/2013

View of pump system on landward side located behind tracker.

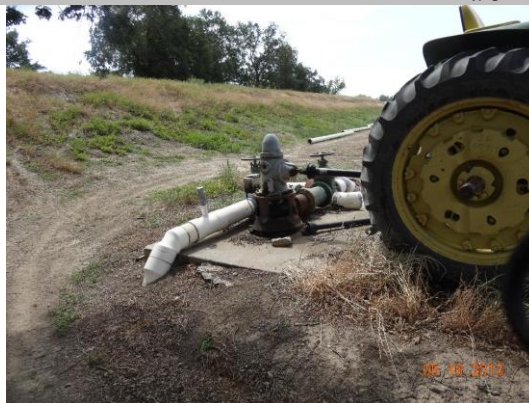
Photo 2 of 3 : UCIP_SP_2019_38178_69501.jpg

Comment Code						
Inspector Comment						
FS_ID:38178 DS_ID:21178 EP_NO: 16931 Repair Type: Non-Urgent Crossing Status: Indicator Found UCIP Comments: Inspector notes indicate that pipe was never installed through levee and application was closed. Steel pipe was not installed but detachable section was installed. The pipe section goes up and over levee. Permit 16931 file was closed in 2005 owner was unable to install pipe due to costs. Permit indicates that pipe was to be used for winter supply of irrigation water to landward side. Need to coordinate with DWR inspector--permit revised for this type of structure. FIELD_STRUCT_DESC: Crossing visible at location. Current structure differs from original request in Permit No. 16931. PVC connection visible on landside (LS) toe with cutoff valve. Pipe connects to 8-inch PVC pipe extending past LS toe. FS Date: 5/16/2013

Pump system located near landward toe.

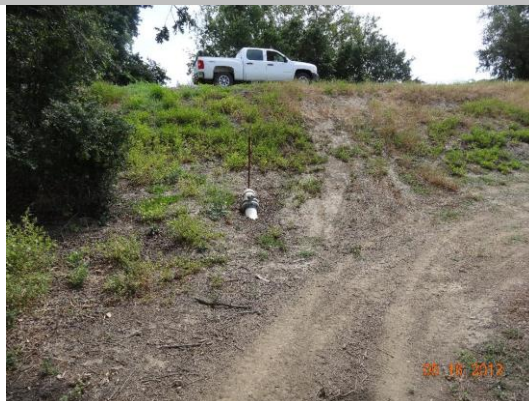
Photo 3 of 3 : UCIP_SP_2019_38178_69500.jpg

LM Start	3.73	Rating **	M	Issue No.	68 (cont)
LM End	3.73	Issue Type +	En	Location *

Pipe connection capped with control valve located on landward toe.

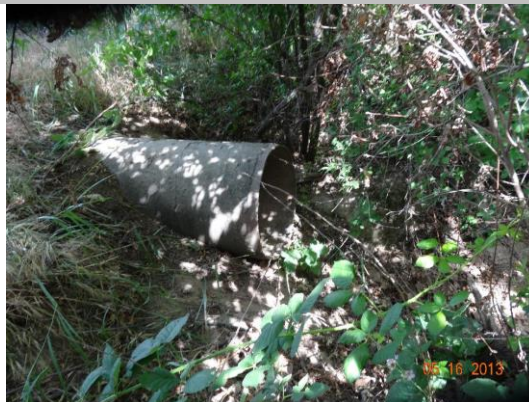
Photo 2 of 3 : UCIP_SP_2019_38182_69533.jpg

Pipe visible on waterward side.

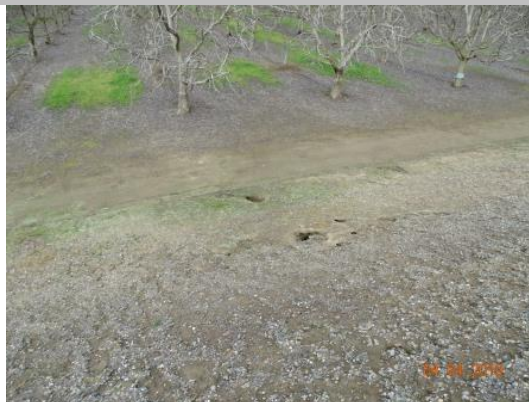
Photo 1 of 1 : SP_2019_LD0002_28_50_20190411_00055.jpg

View of the rodent holes on the landside slope. Spring 2019.

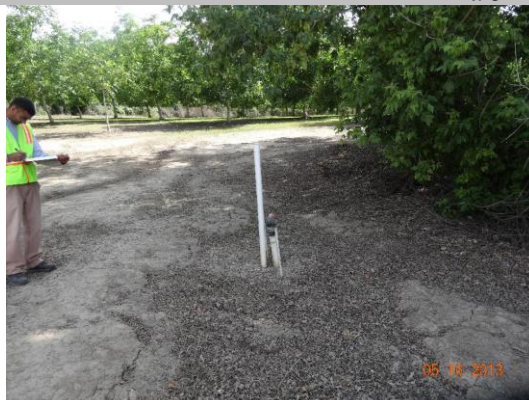
Photo 1 of 3 : UCIP_SP_2019_44188_69544.jpg

3-inch PVC pipe and vent exposed on waterward toe, likely in alignment with this crossing.

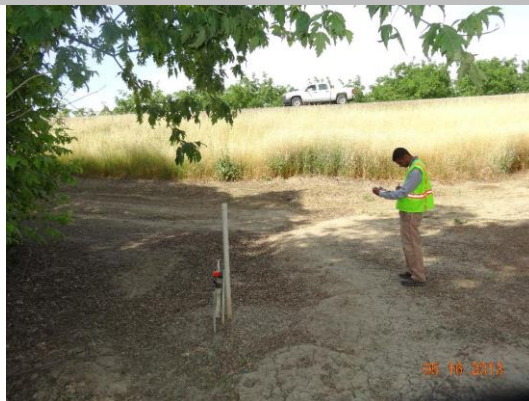
Photo 2 of 3 : UCIP_SP_2019_44188_69543.jpg

3-inch PVC pipe and vent exposed on waterward toe, likely in alignment with this crossing.

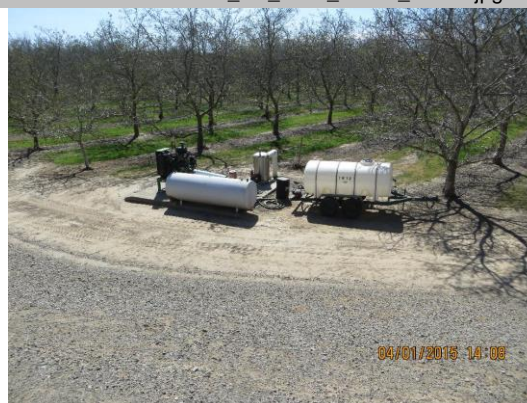
Photo 3 of 3 : UCIP_SP_2019_44188_73609.jpg

Well and pump visible on LS toe.

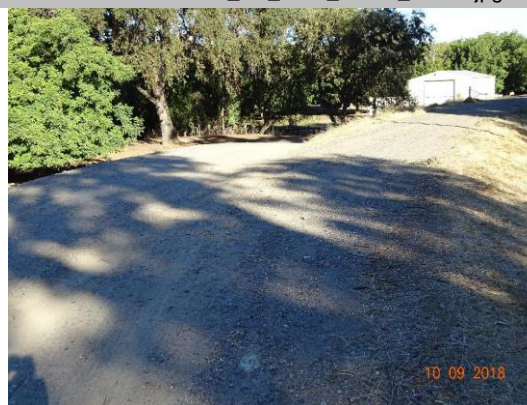
Photo 1 of 3 : UCIP_SP_2019_53005_78119.jpg

View of levee crown at the crossing.

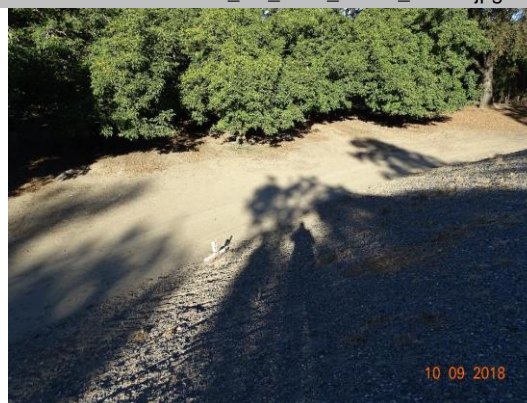
Photo 2 of 3 : UCIP_SP_2019_53005_78120.jpg

View of landside at crossing.

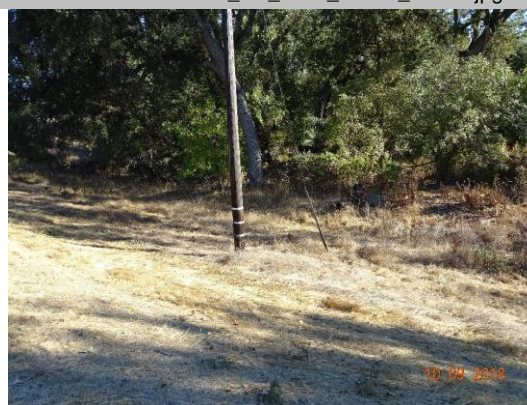
Photo 3 of 3 : UCIP_SP_2019_53005_78121.jpg

View of waterside at crossing.
